TOWN OF MIDDLEBURY, VERMONT

SEWER SYSTEM EVALUATION STUDY – PHASE I

SEPTEMBER 2013

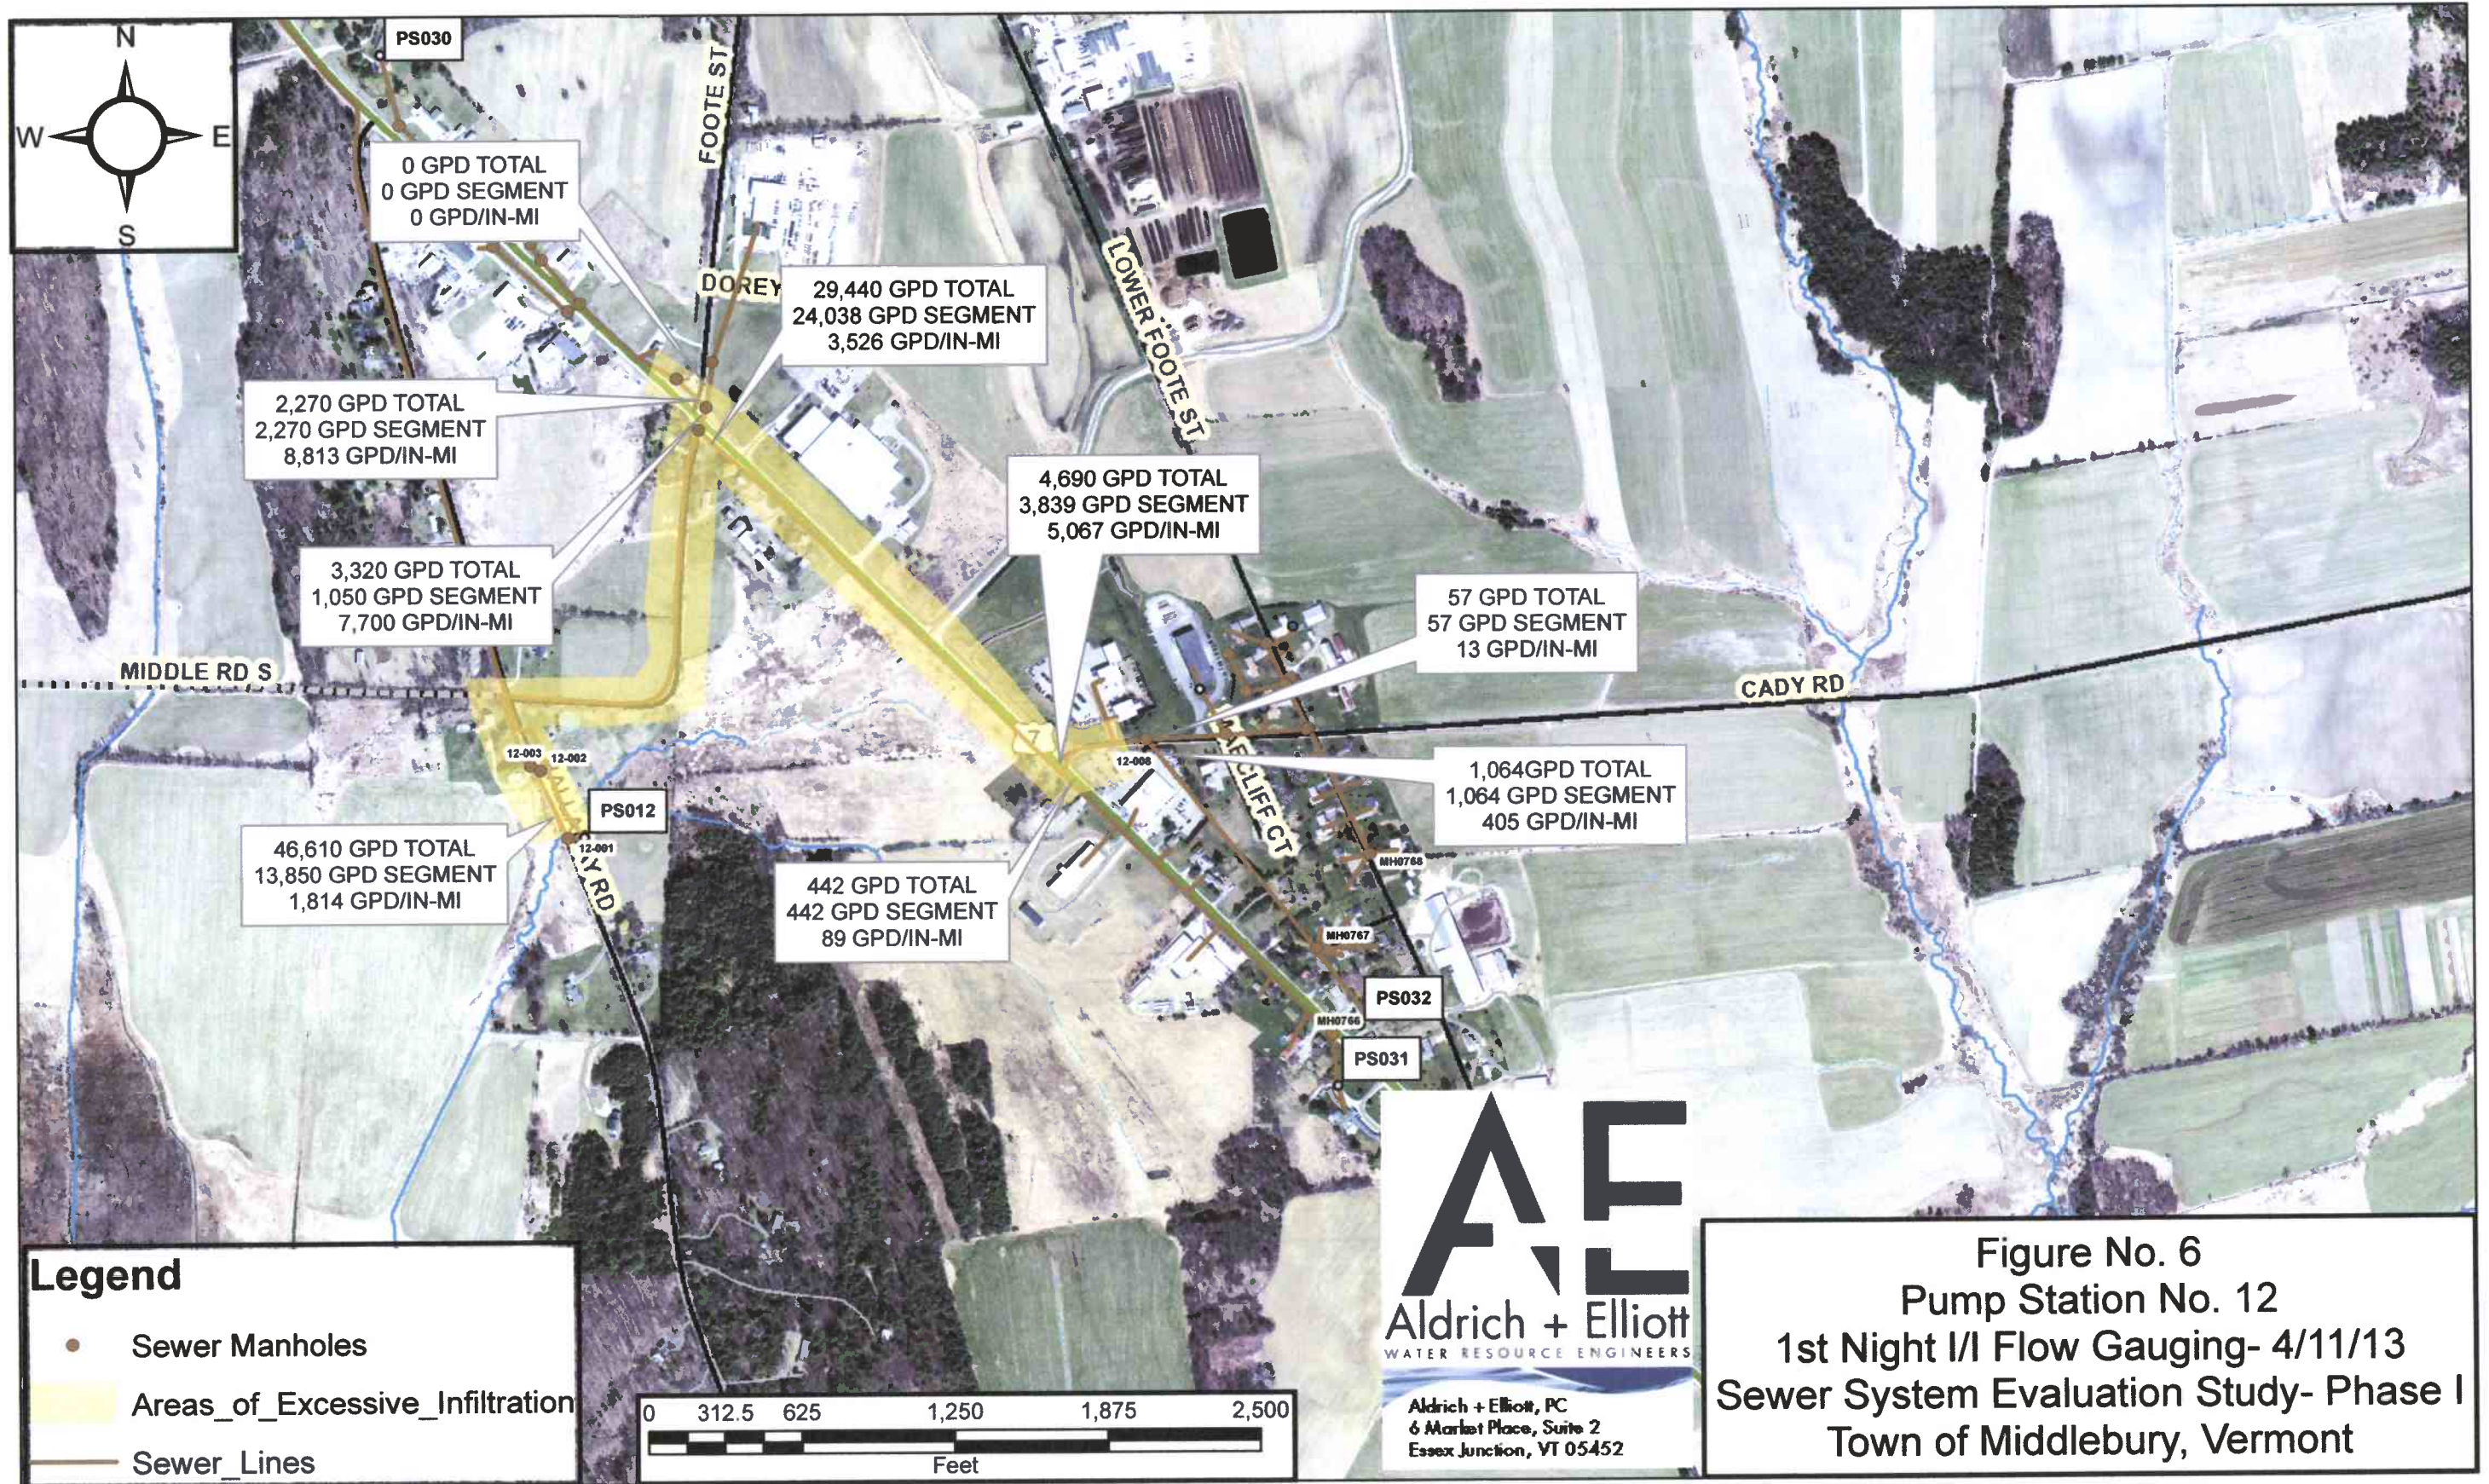
Figure No. 6
Pump Station No. 12
1st Night I/I Flow Gauging- 4/11/13
Sewer System Evaluation Study- Phase I
Town of Middlebury, Vermont

For the Halladay Pump Station (PS#12) service area, the 1st night of flow gauging resulted in two (2) large areas of excessive infiltration as shown on Figure No. 6 including:

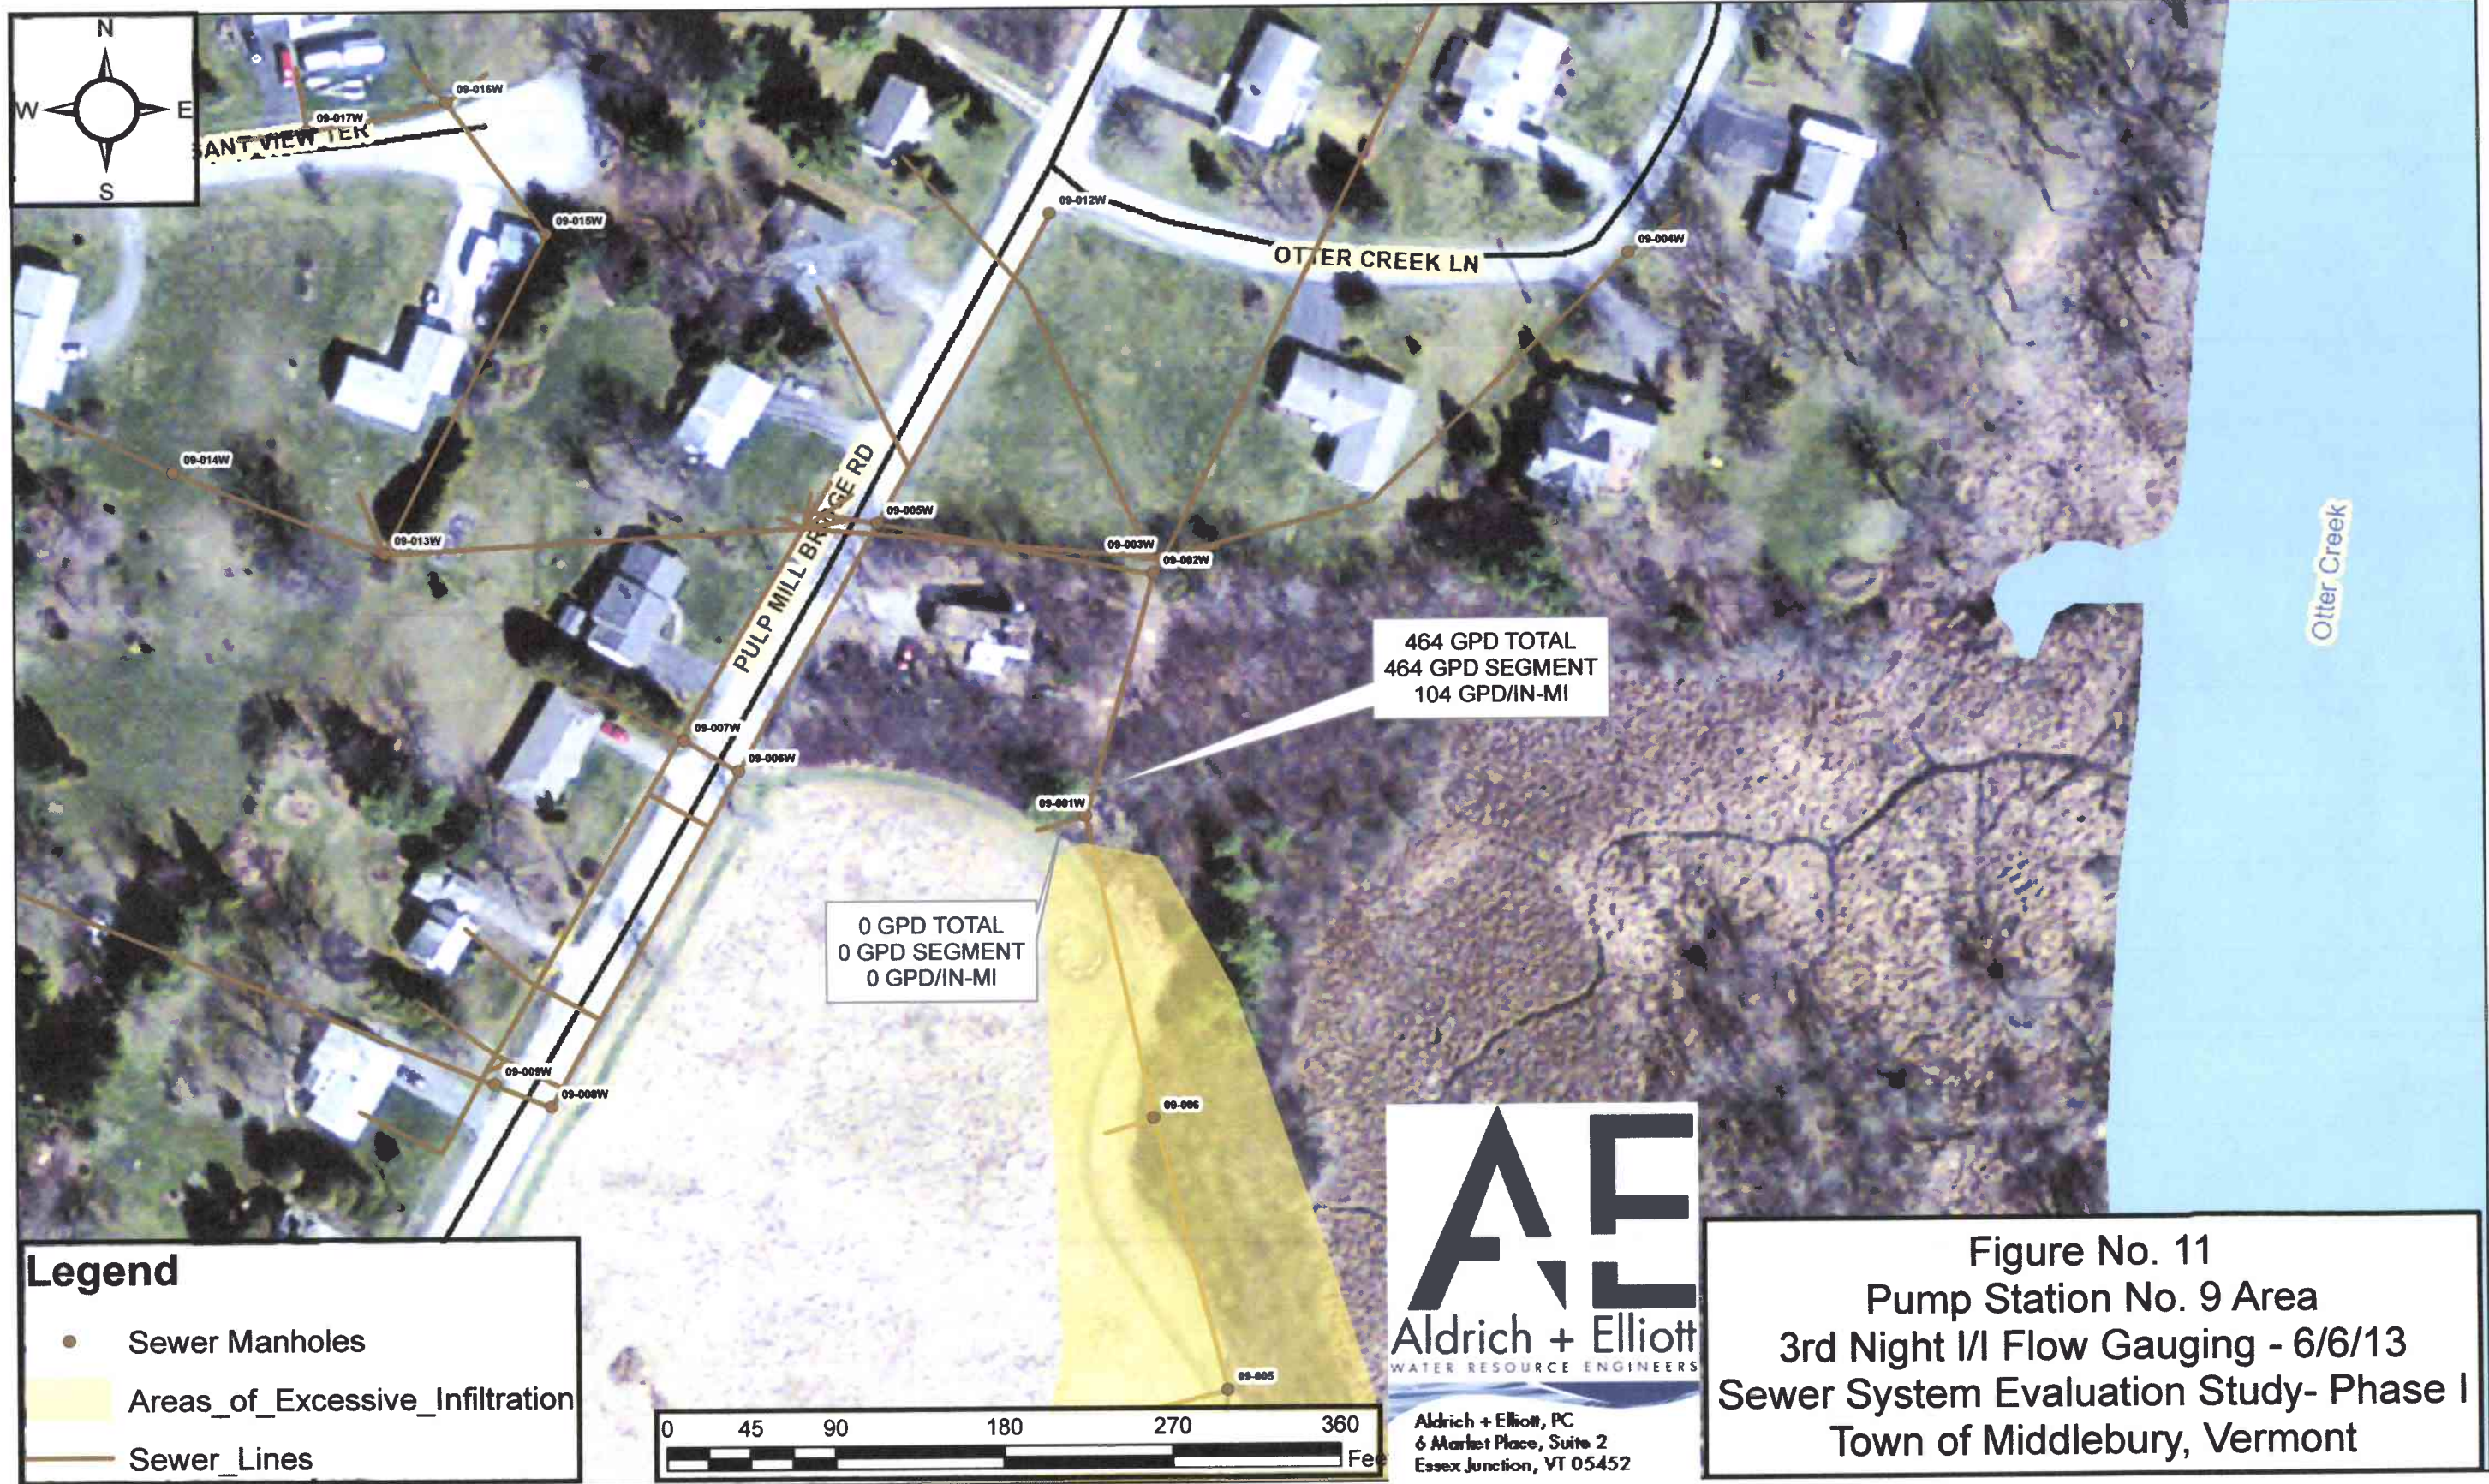
Figure No. 11
 Pump Station No. 9 Area
 3rd Night I/I Flow Gauging - 6/6/13
 Sewer System Evaluation Study- Phase I
 Town of Middlebury, Vermont

Figure No. 11 provides a map of the gauging locations along with the total measured flow, segment flow and infiltration flow rate. The following is a summary of the flow gauging results:

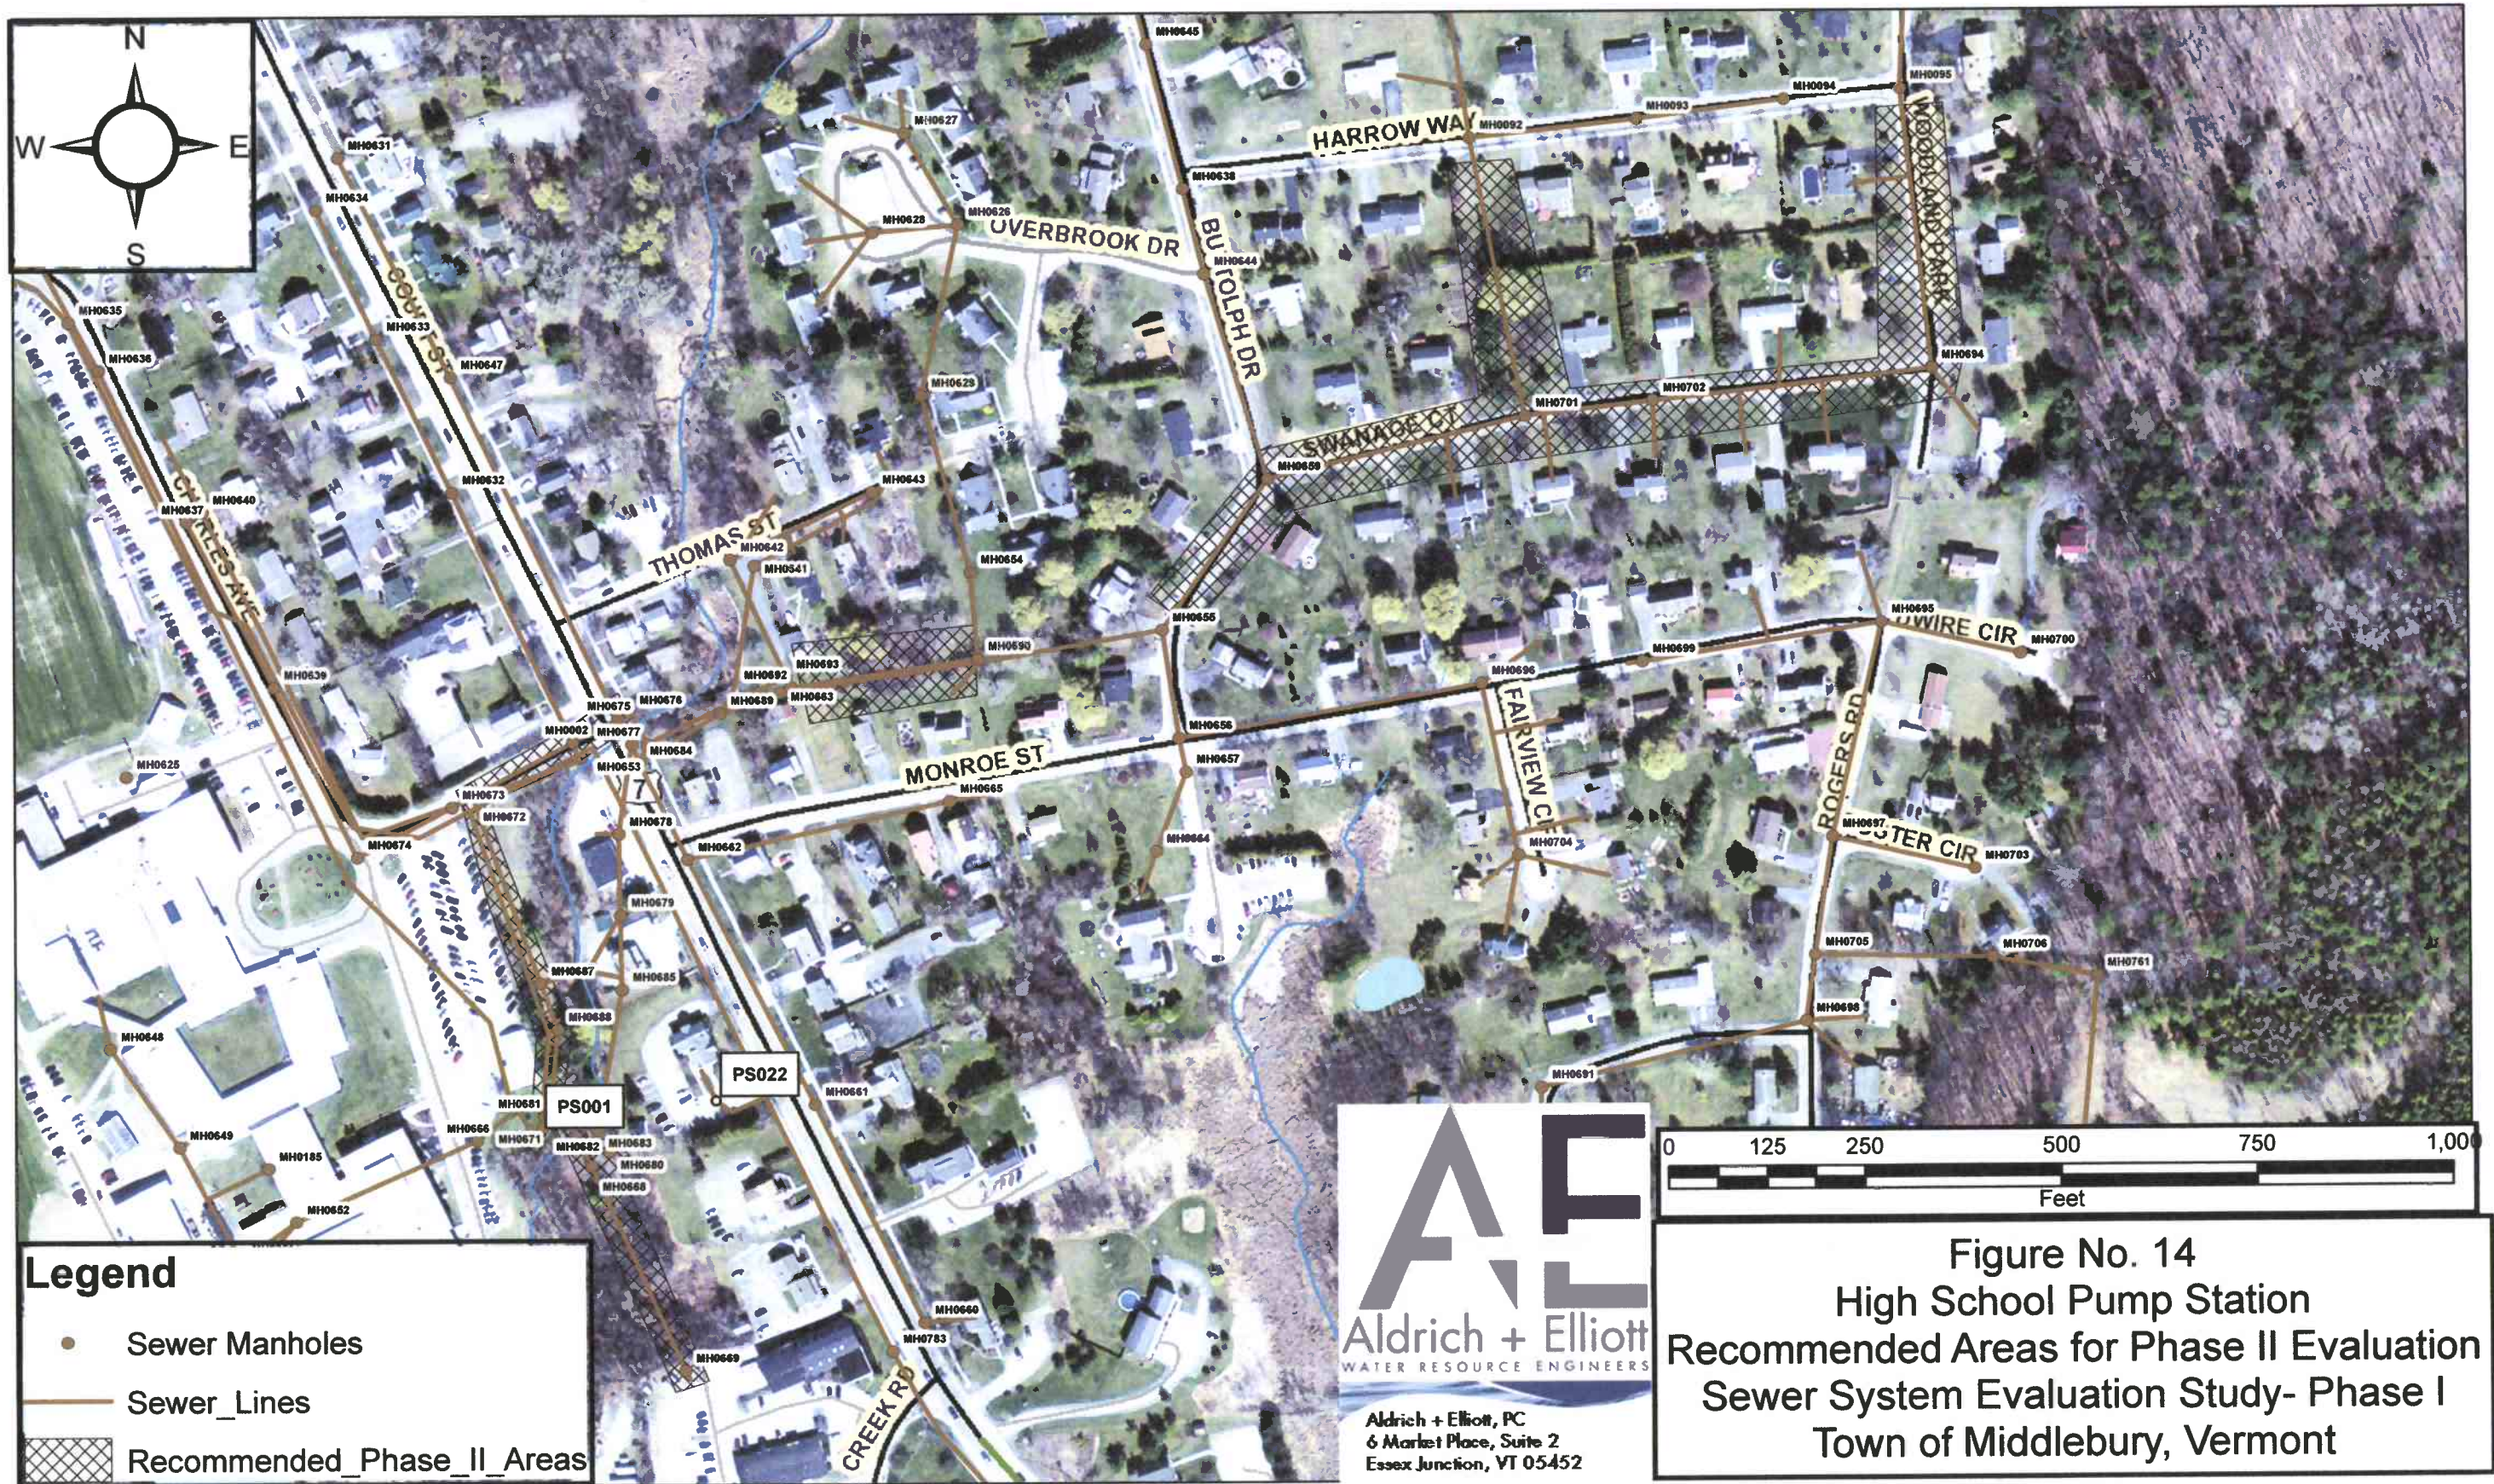
Figure No. 13
Manhole Inspection Map
Exchange Street trunk Sewer
Sewer System Evaluation Study- Phase I
Town of Middlebury, Vermont

Fourteen (14) manhole structures along the Exchange Street trunk sewer were inspected on December 20, 2013. The deficiencies of these manholes included:

Recommendations for manhole rehabilitation are included in the report.

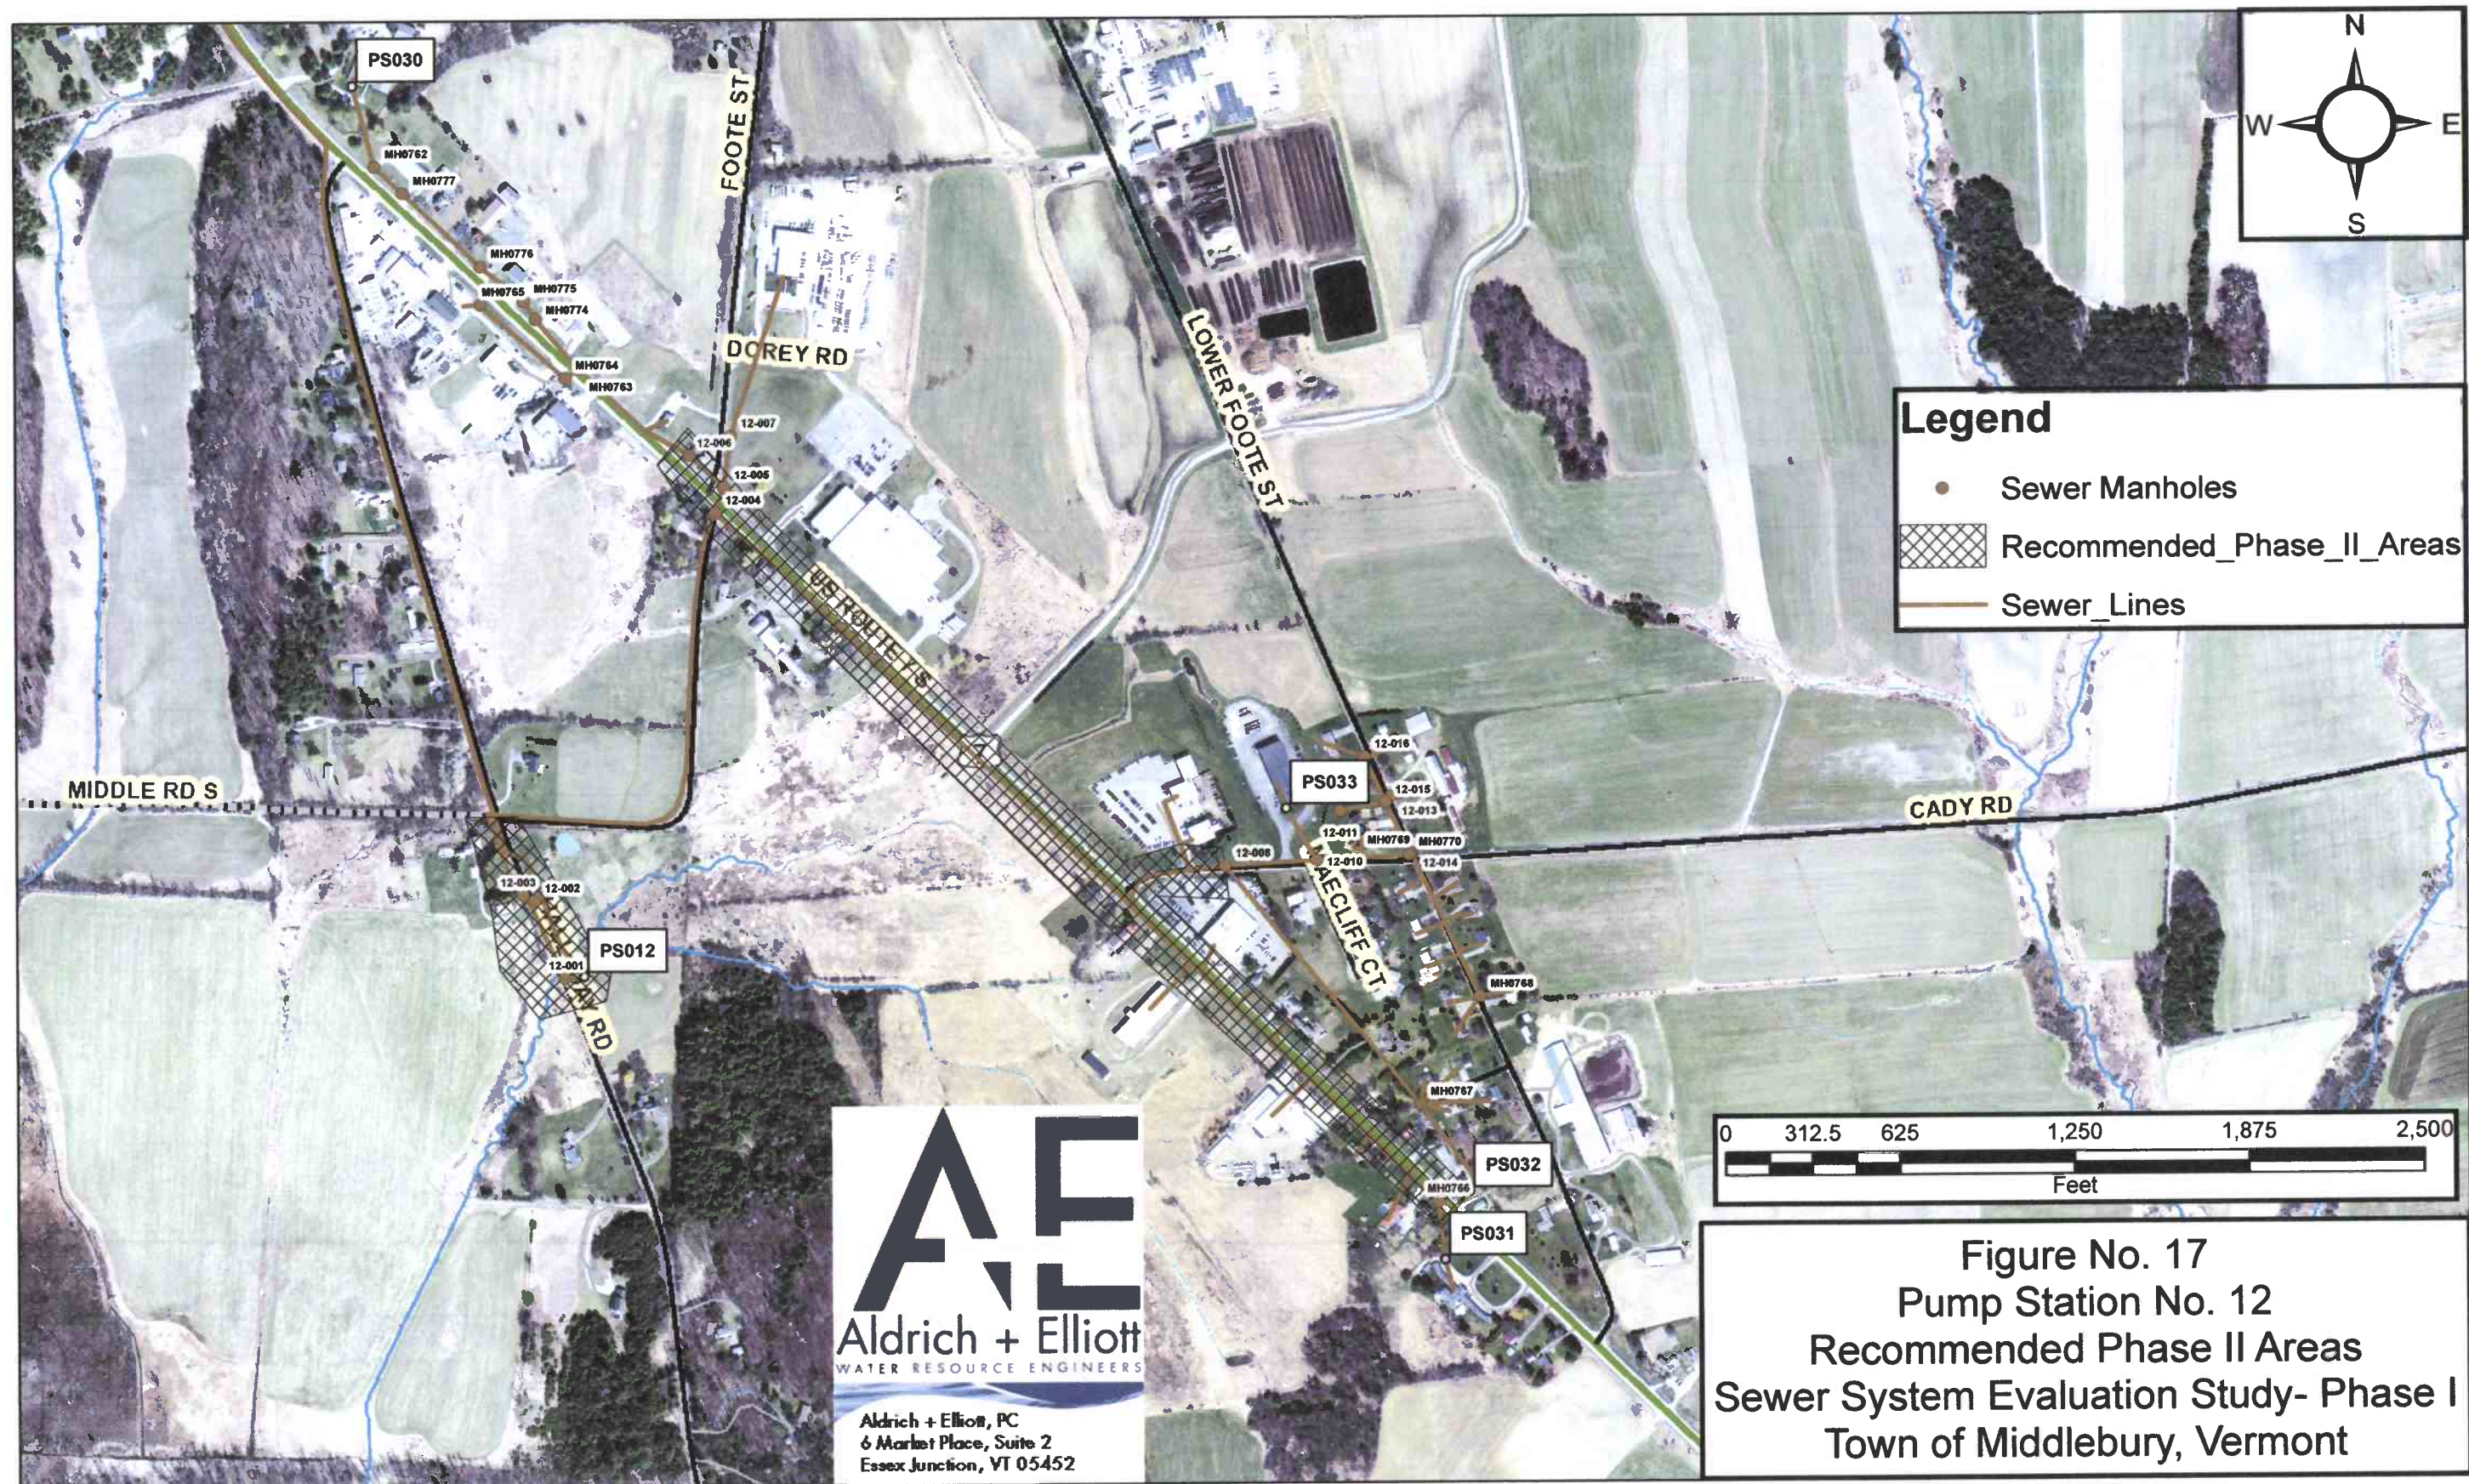
Figure No. 15
Pump Station No. 6 Area
Recommended Phase II Study Areas
Sewer System Evaluation Study-Phase I
Town of Middlebury, Vermont

- High School Pump Station (PS #1)- Figure No. 14
- Seminary Pump Station (PS #6)- Figure No. 15
- Weybridge Pump Station (PS #9)- Figure No. 16
- Halladay Pump Station (PS #12)- Figure No. 17

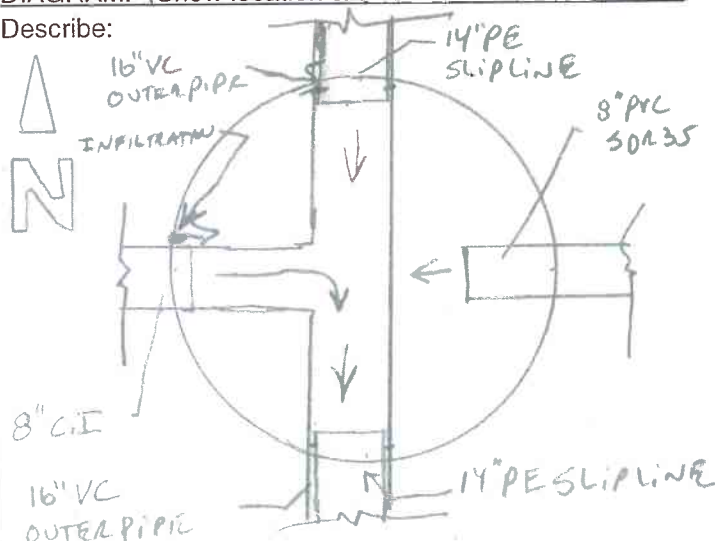
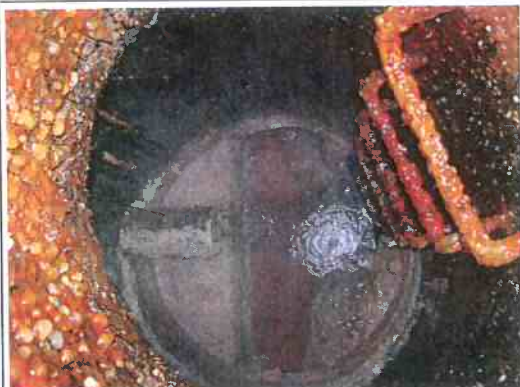
Drain Holes? Y ☒ How Many? ____
Material: CI ☒ Concrete ☐ Other ☐
Cover Size: 24" Diameter or ____ x ____
Clear Opening 22" Diameter or ____ x ____
Mortared? Y ☒ Centered? ☒ N
General Condition:
Biological slime on inside.

Uniform ☐ Non-Uniform ☒
Smooth ☐ Rough ☒
Solids Accumulated? Y ☒
Brick ☒ Concrete ☐ PVC ☐
Describe:
Minor concrete deterioration and spalling. Significant slime growth.

SHELF: None ☐ Mortar ☒ Brick ☐ Sloped ☒ Smooth ☐ Rough ☒
Describe: Mortar deteriorated and concrete spalling.

CRACKS? ☒ N Describe: Hole in MH Wall.

Minor roots on walls. Minor deterioration and spalling of concrete walls.

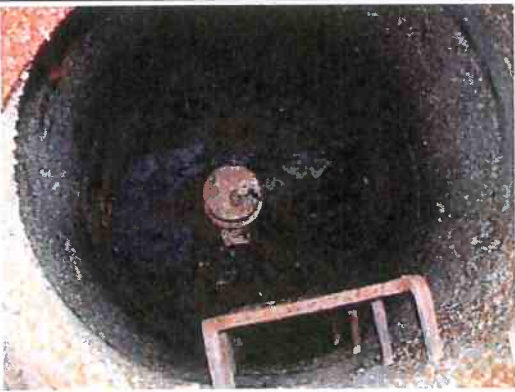
INVERT: Uniform <input type="checkbox"/> Non-Uniform <input type="checkbox"/> Smooth <input type="checkbox"/> Rough <input type="checkbox"/> Solids Accumulated? Y <u>(N)</u> Brick <input type="checkbox"/> Concrete <input type="checkbox"/> PVC <input type="checkbox"/> Describe: <u>Good condition.</u> <u>None Straight 14" PE hard piped</u>		RISERS AND JOINTS: Flat Top _____ Conical Top <u>1</u> No. of Risers <u>1</u> Base <u>1</u> Mortared _____ Other _____	
		LADDER RUNGS: Aluminum <input checked="" type="checkbox"/> Iron <input type="checkbox"/> Plastic <input type="checkbox"/> Appear Safe? <u>(Y)</u> N Other: <u>Coated with slime</u>	
		DIMENSIONS: Depth <u>9'-6"</u> +/- (Rim to Invert) Inside Dia. <u>4'-0"</u> Inside Dimensions: _____ x _____ Other: _____	
SHELF: None <input type="checkbox"/> Mortar <input checked="" type="checkbox"/> Brick <input type="checkbox"/> Sloped <input checked="" type="checkbox"/> Smooth <input type="checkbox"/> Rough <input type="checkbox"/> Describe: _____

NOTICEABLE DEFICIENCIES: GRIT? Y <u>(N)</u> Amount: _____ CLEANLINESS: <u>(Y)</u> N Describe: _____ EXTRANEIOUS WATER? Y <u>(N)</u> Quantity: _____ Location: _____ CRACKS? Y <u>(N)</u> Describe: _____			
OTHER COMMENTS AND REMARKS: <u>Cleanout in center of pipe. Not good access for maintenance/cleaning.</u> <u>Minor deterioration/spalling of concrete walls.</u>		DIAGRAM: (Show location & size of all inlets and outlets) Describe: <div style="text-align: center;"> </div>

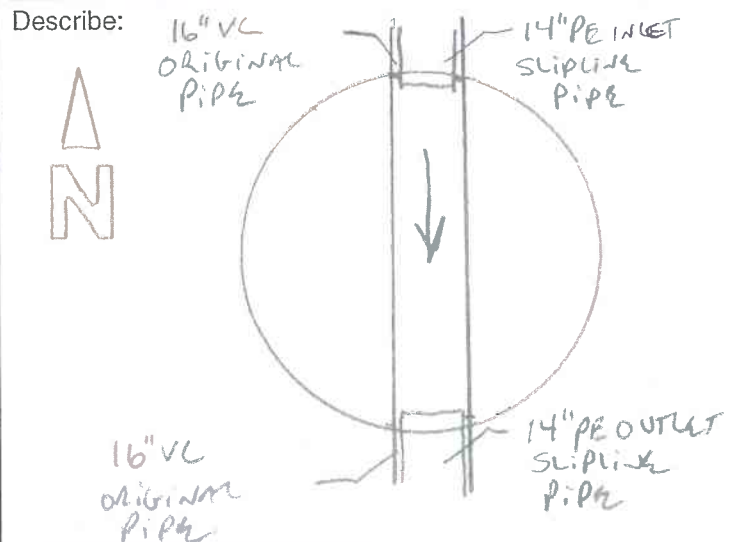
NOTICEABLE DEFICIENCIES: Evidence of Surcharging? ☒ Y N
GRIT? Y ☒ N Amount: _____ Lift Holes Plugged? ☒ Y N
CLEANLINESS: ☒ Y N Describe: Manhole walls covered in bacterial slime growth.
EXTRANEIOUS WATER? ☒ Y N Quantity: Weeping Location: At both pipe connections and base/riser joint.
CRACKS? ☒ Y N Describe:

OTHER COMMENTS AND REMARKS:
Inlet pipe leaking between 12" PE slipline and 14" original pipe.

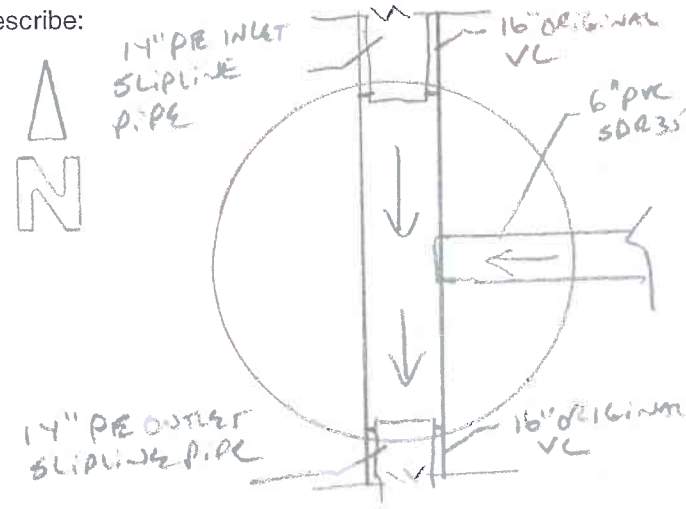
NOTICEABLE DEFICIENCIES: Evidence of Surcharging? Y ☒ N
GRIT? Y ☒ N Amount: _____ Lift Holes Plugged? ☒ Y N
CLEANLINESS: ☒ Y N Describe: Manhole walls covered in bacterial slime growth.
EXTRANEIOUS WATER? ☒ Y N Quantity: 5 gpm Location: Hole in MH Wall and under frame.
CRACKS? ☒ Y N Describe: Hole in MH Wall.
